PROJECT REPORT

Façade Maintenance Work for Pragati Building at L&T Electrical & Automation Division, Mahape

18 November 2019

10 January 2020

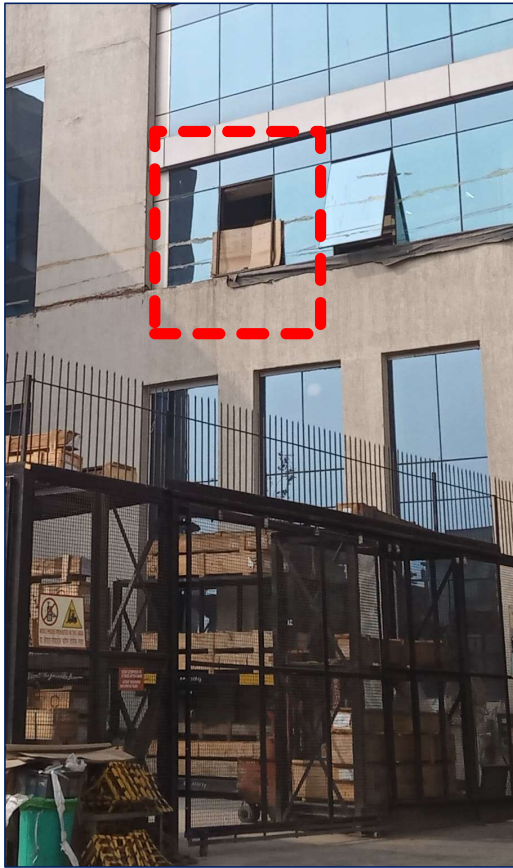
Broken Glass of Window 1507
(Before)

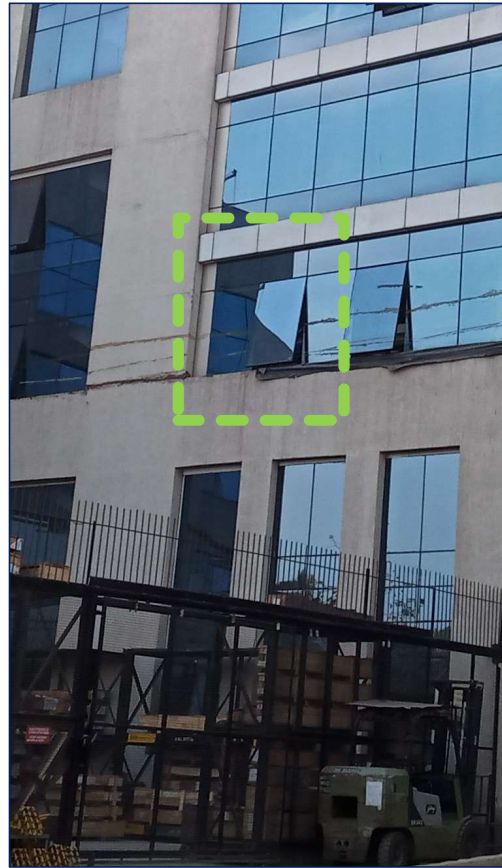
Window 1507 (After Glass
Replacement)

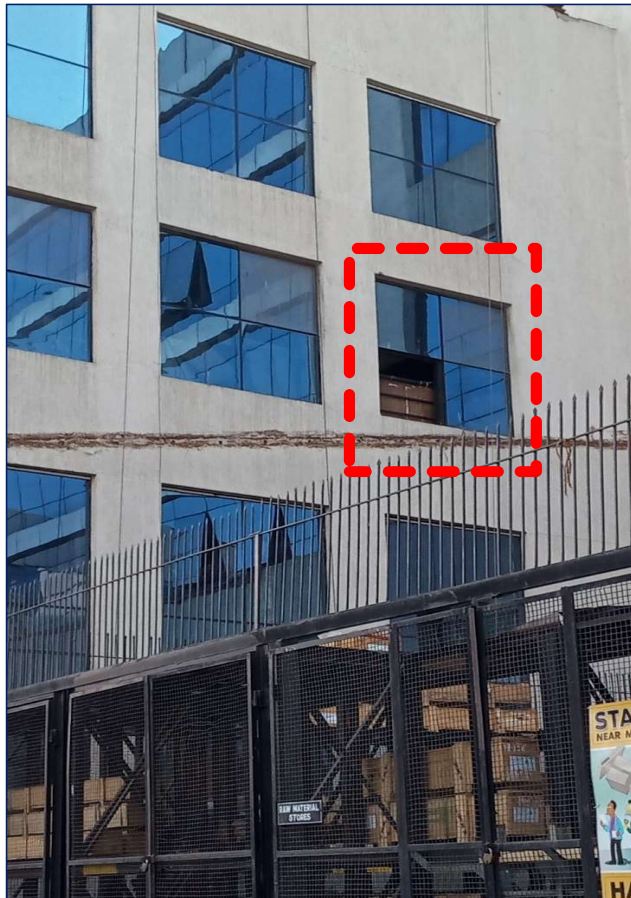
Broken Glass of Fixed Panel 380
(Before)

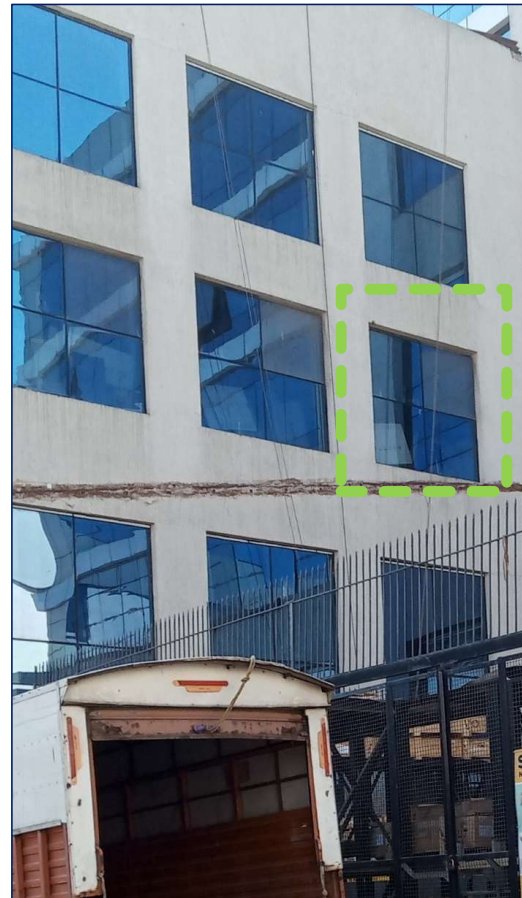
Fixed Panel 380(After Glass
Replacement)

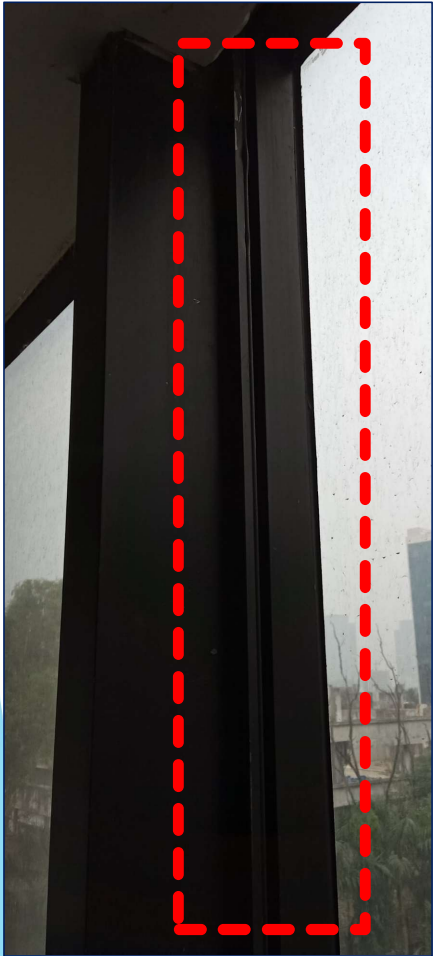
Misalignment of Existing Panels

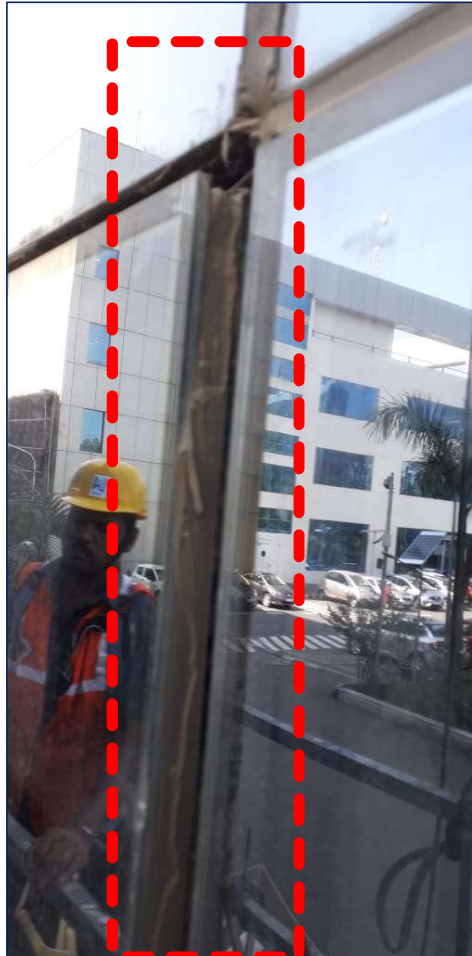
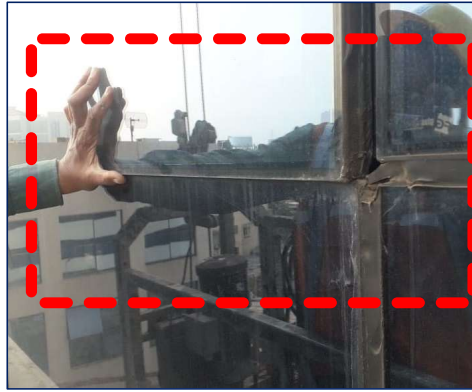
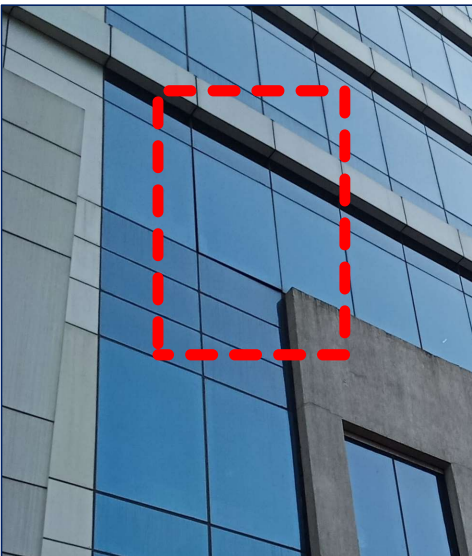
Broken Hinge
Window 377

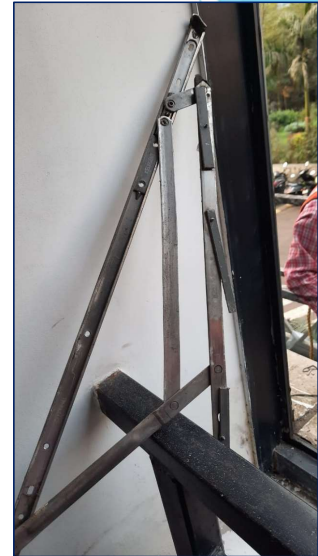
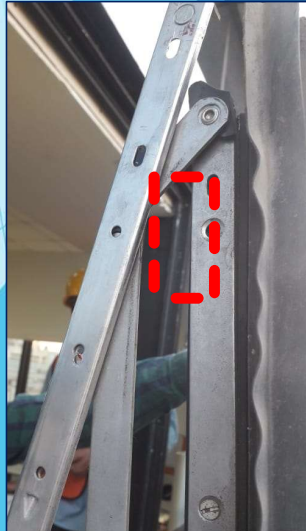
Missing Screws

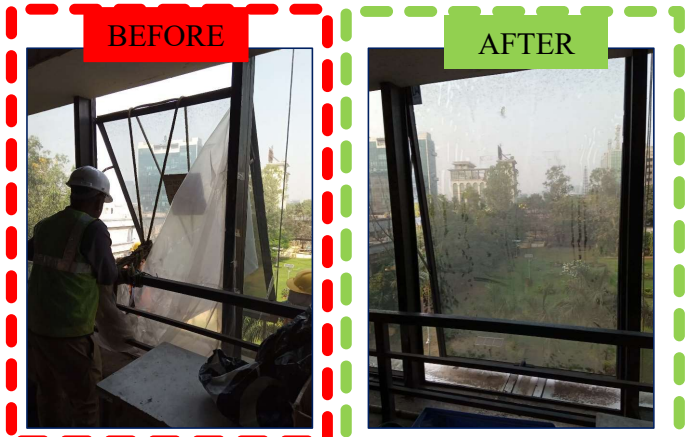
Window 59: Tied With Ropes due to Broken Hinges.
Hinges replaced and Restrictor Arms installed.

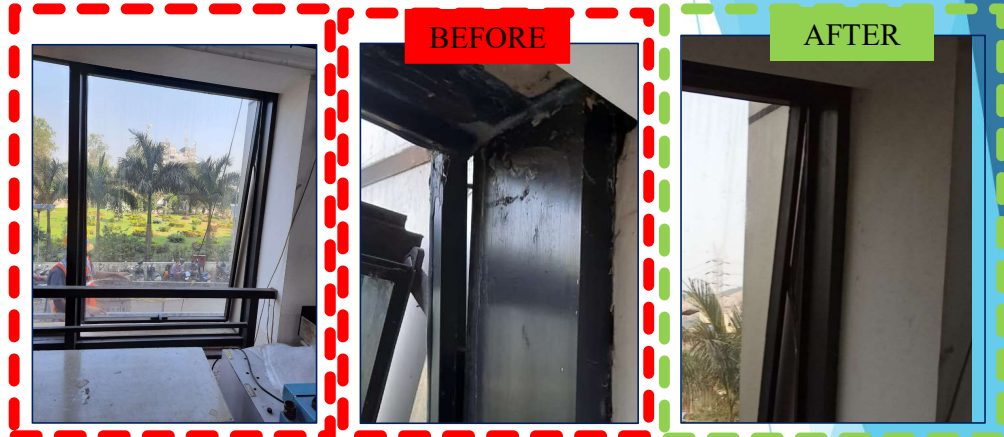
Window 382 : Frame Dislodged.
Window-Reinstalled and Restrictor Arms installed.

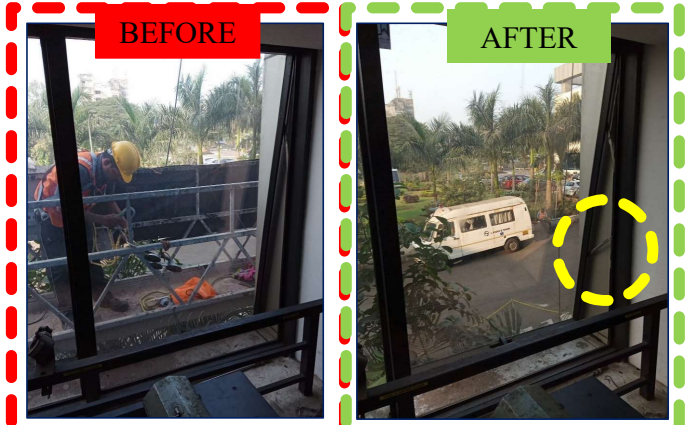
Window 379: Window Rubbing to ACP at Sides.

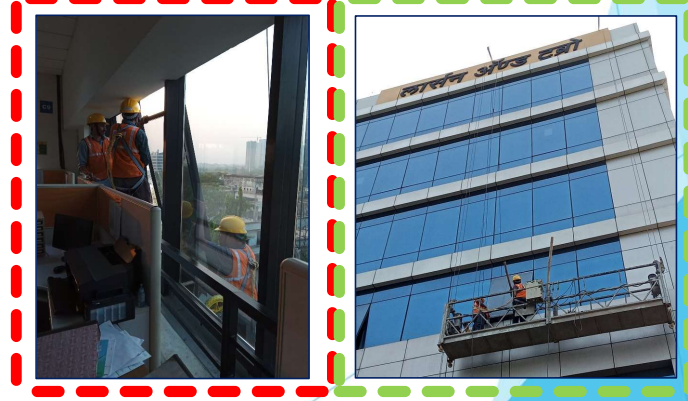
Window 238 at Office: Re-installed. Panel was shifted Down by 5mm approx.

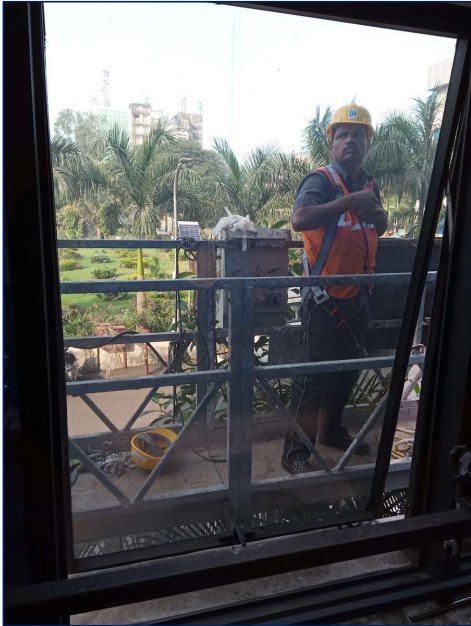
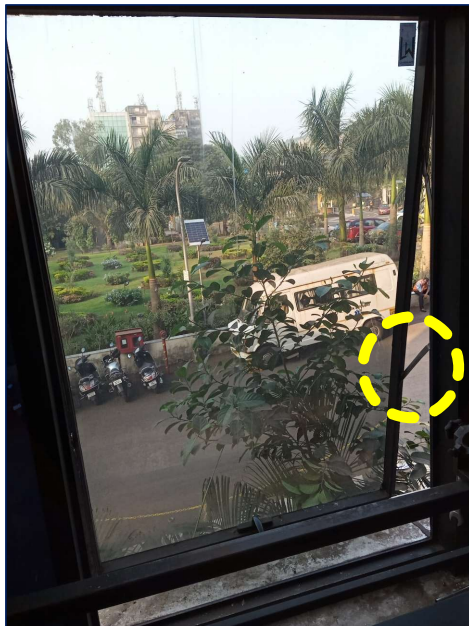
Window 380: Restrictor Arms Installed

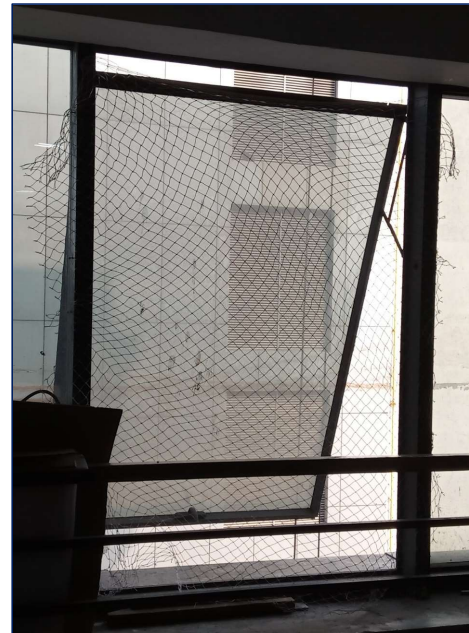
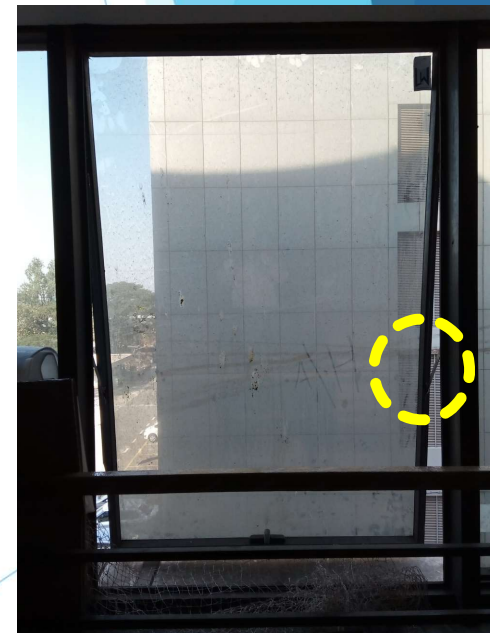
Window 41: Open Window was difficult to pull back for locking.
Hinges Replaced & Restrictor Arms Installed

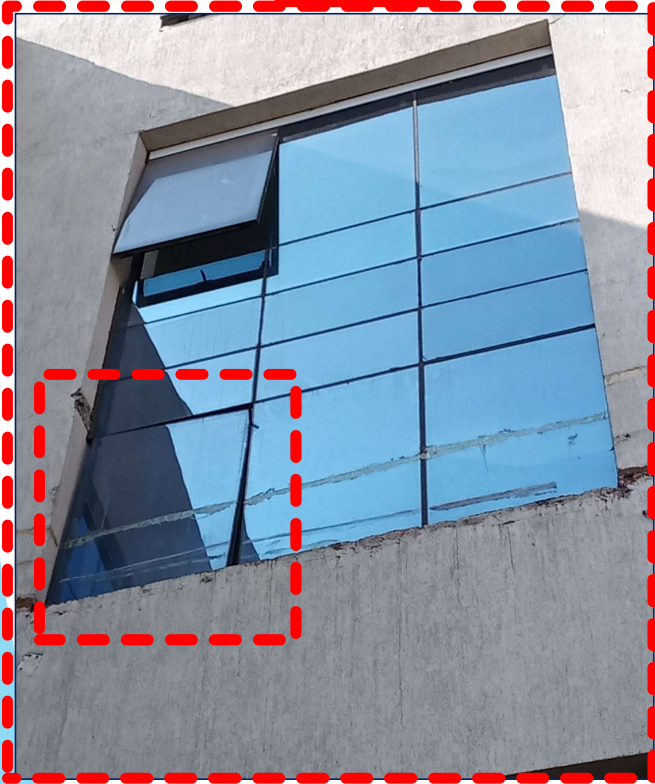
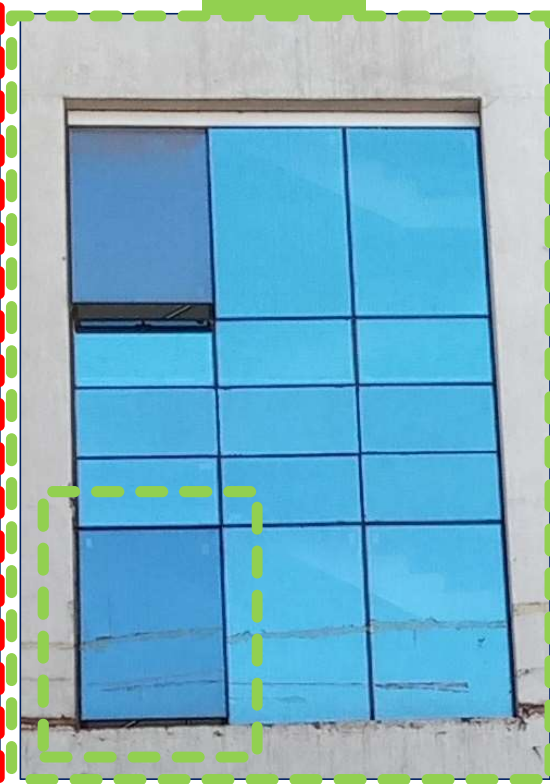
Window 1442: Misaligned Top Hung Window about to fall.

Hinges replaced and Restrictor Arms installed

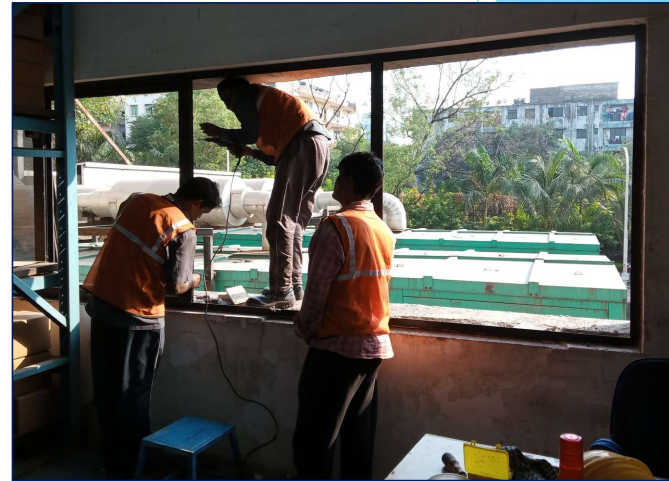
Maintenance of Window 1070, 1071, 1072.

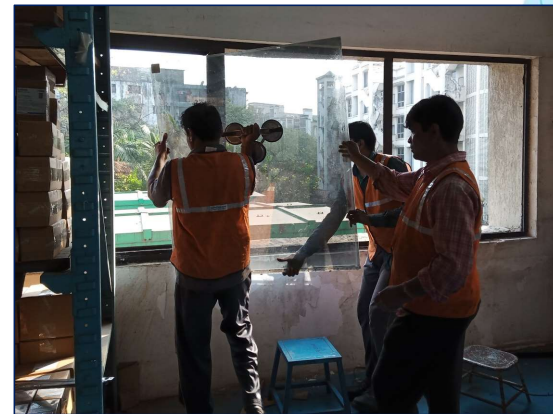
Window 1072 Installation of Glass to convert Panel from Openable to Fixed.

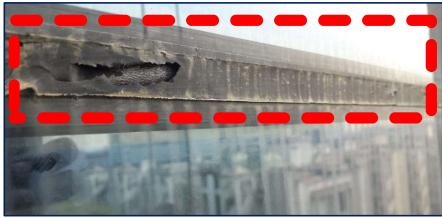
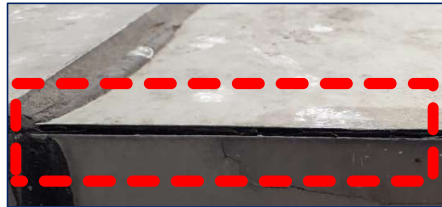
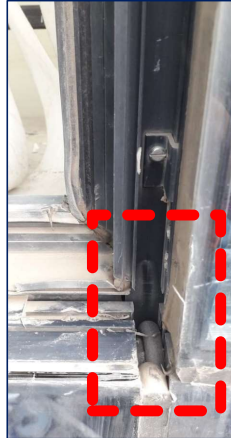
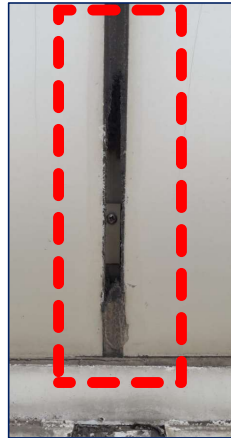
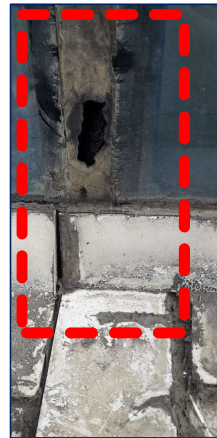
Reason of Leakage - Worn Out Sealant / Removal of Existing Sealant by Birds

Dry sealant removed out from Grooves causing leakage inside.

Gaps noted between ACP sheet joints.

Cracks noted at bends of ACP cladding

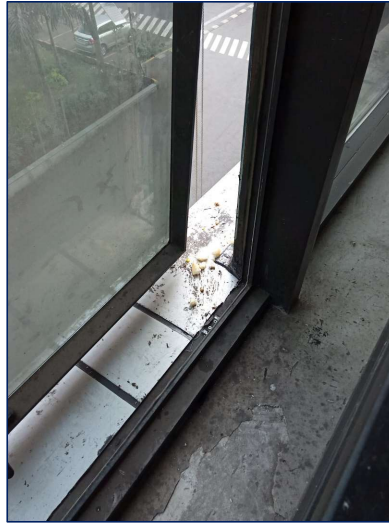
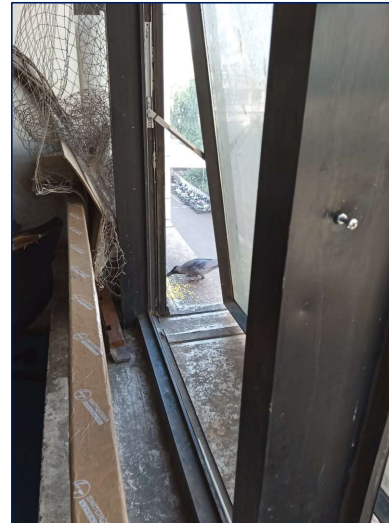
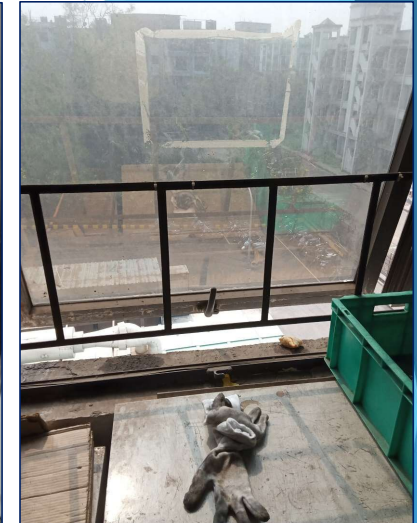
Keeping food for birds causes their repetitive presence at ACP Band and it is observed that Birds are digging the sealant by their Peak.

AVOID KEEPING FOOD OUTSIDE WINDOWS.
