PROJECT : INSPIRE BKC

Inspection Report Prepared by:
Pankaj Ghare (Landscape Wall Systems) 9819663630

INSPECTION -1

INSPECTION -2

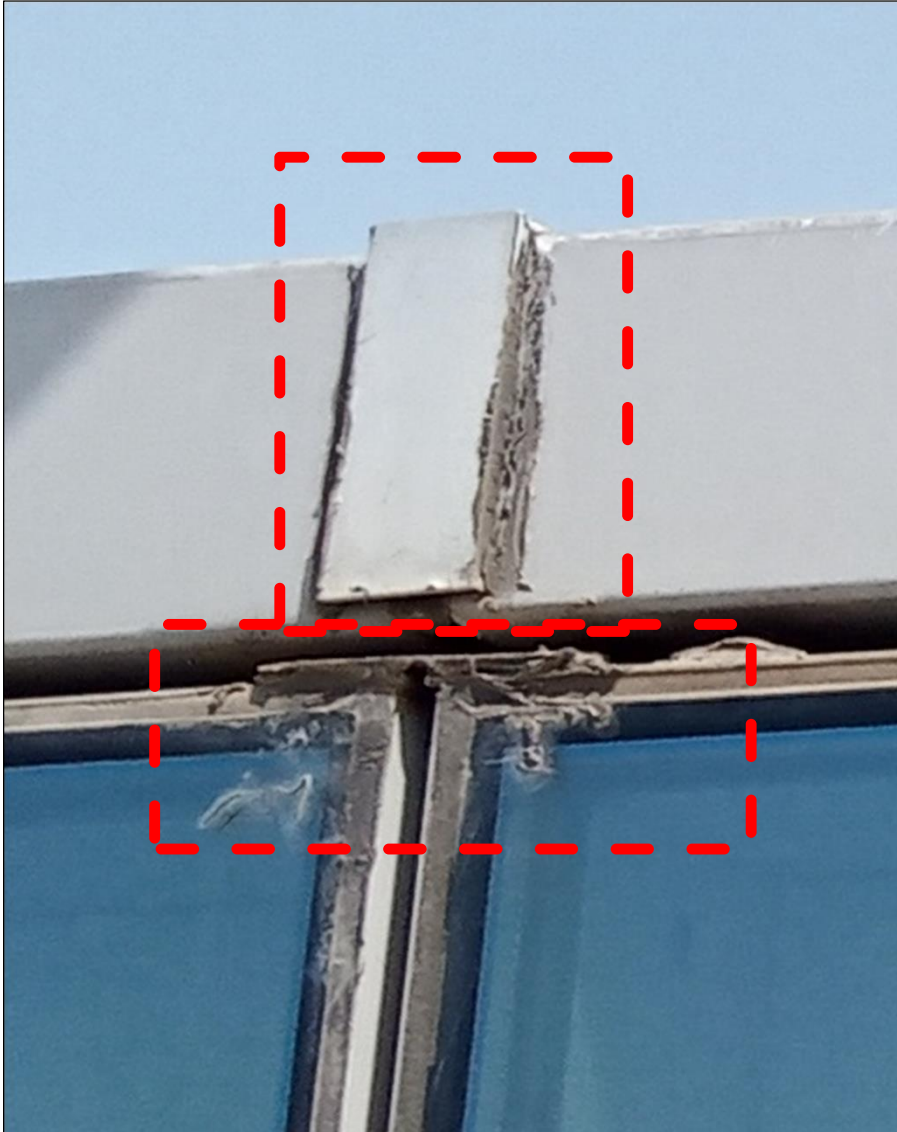
Terrace Floor

- Insufficient Silicone Filling at Side of ACP Strips
- Insufficient packing at top of Mullion

- Remove existing old silicone and replace with Fresh Silicone
- Fill the Gap at sides of Covering plate by Backer Rod and apply silicone at sides

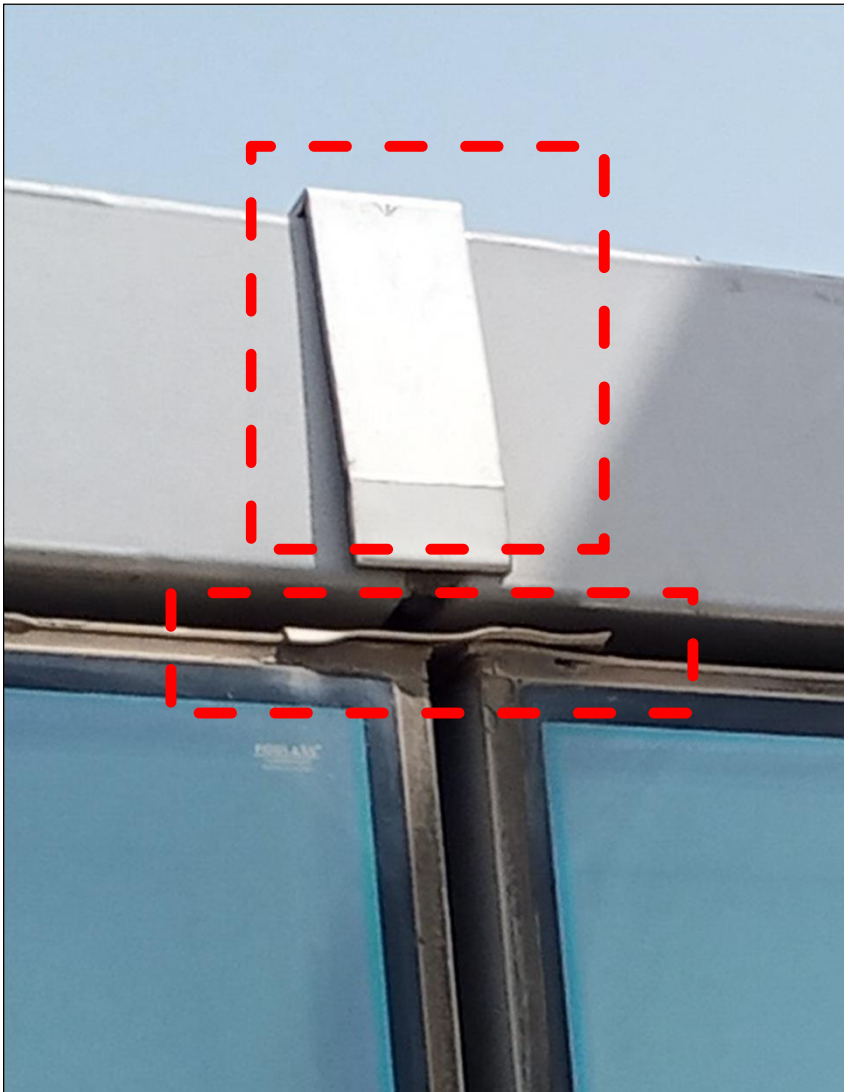
Terrace Floor

- Absence of Silicone at Side of ACP Strips
- Insufficient packing at top of Mullion

- Apply with Fresh Silicone at sides of ACP strips.
- Fill the Gap at sides of Covering plate by Backer Rod and apply silicone at sides

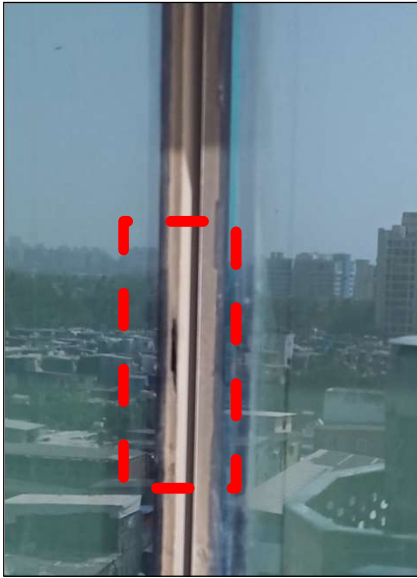
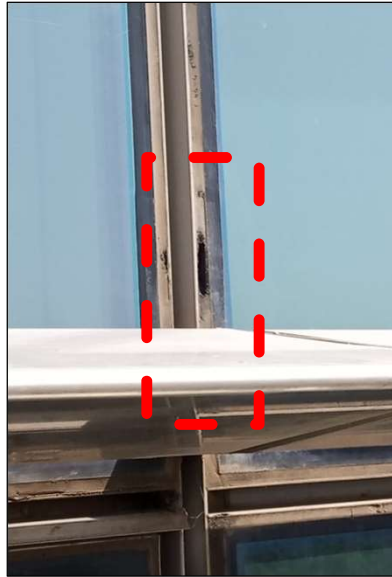
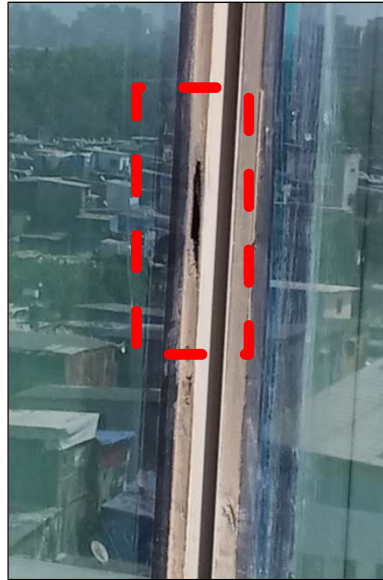
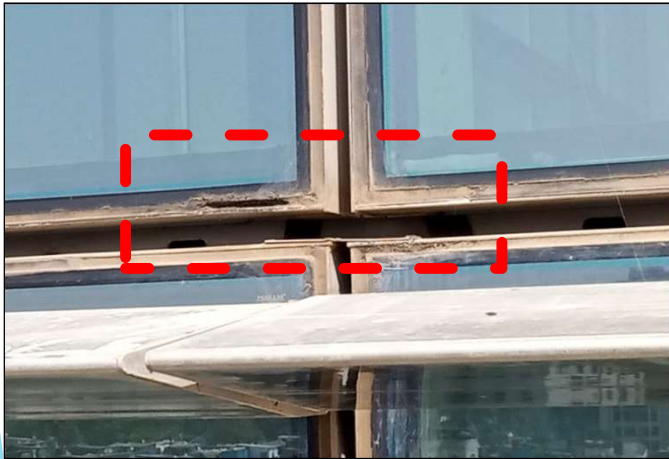
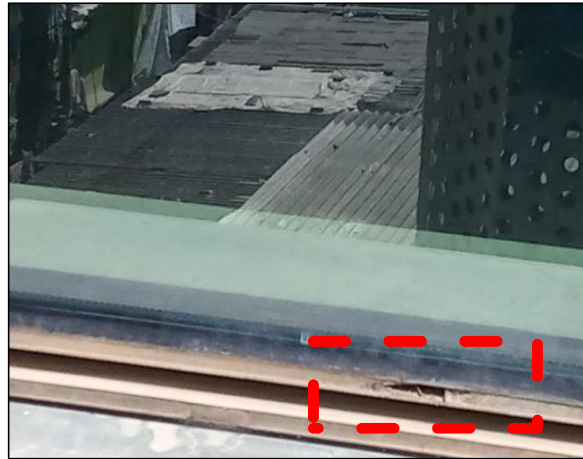
Location: Various Locations

Silicone Removed (by Birds)

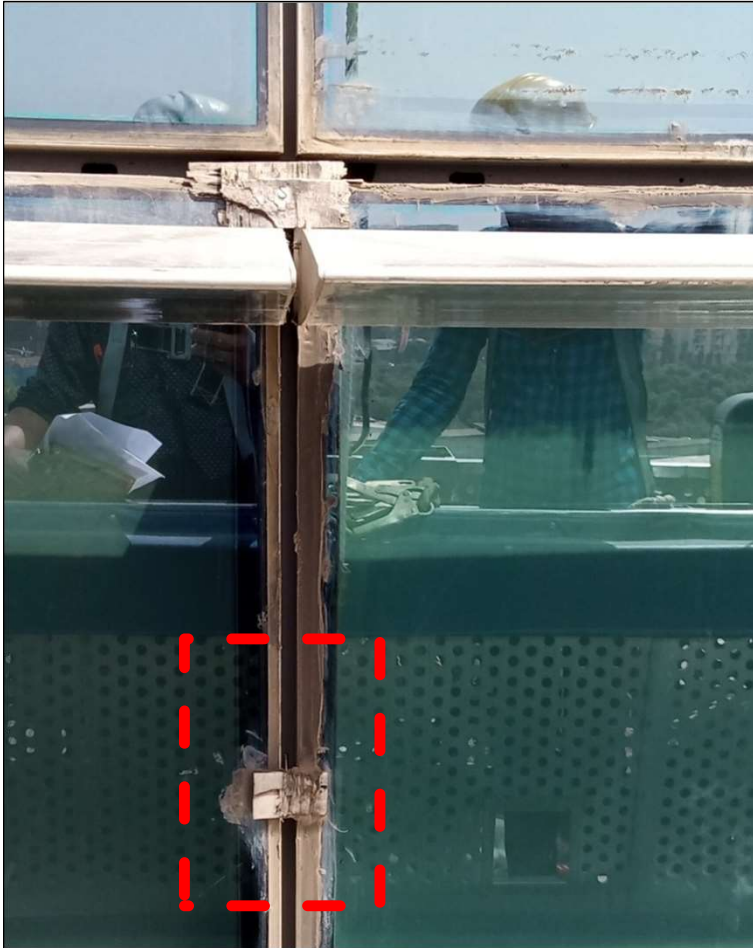
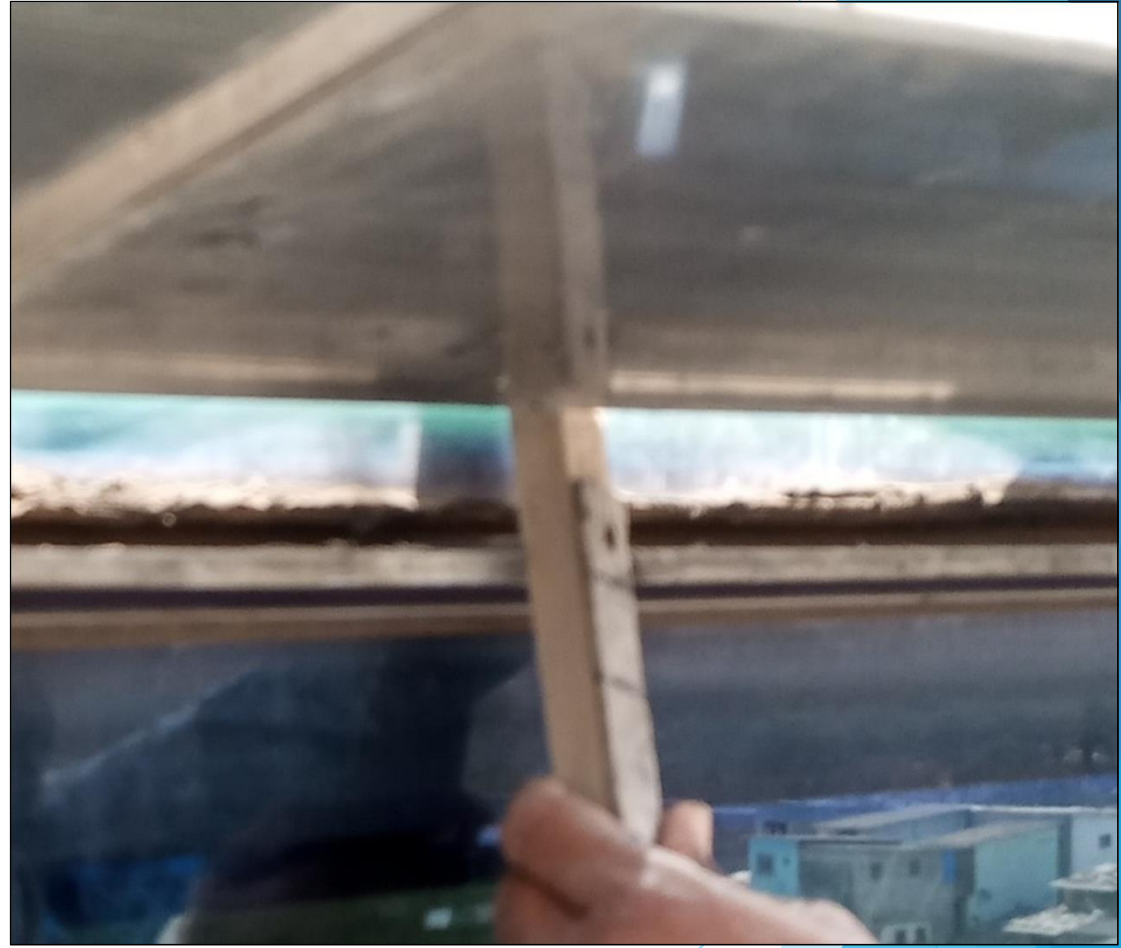
Location: Various Locations

Screws used for Fixing the toggles to be removed and Fresh Silicone to be applied

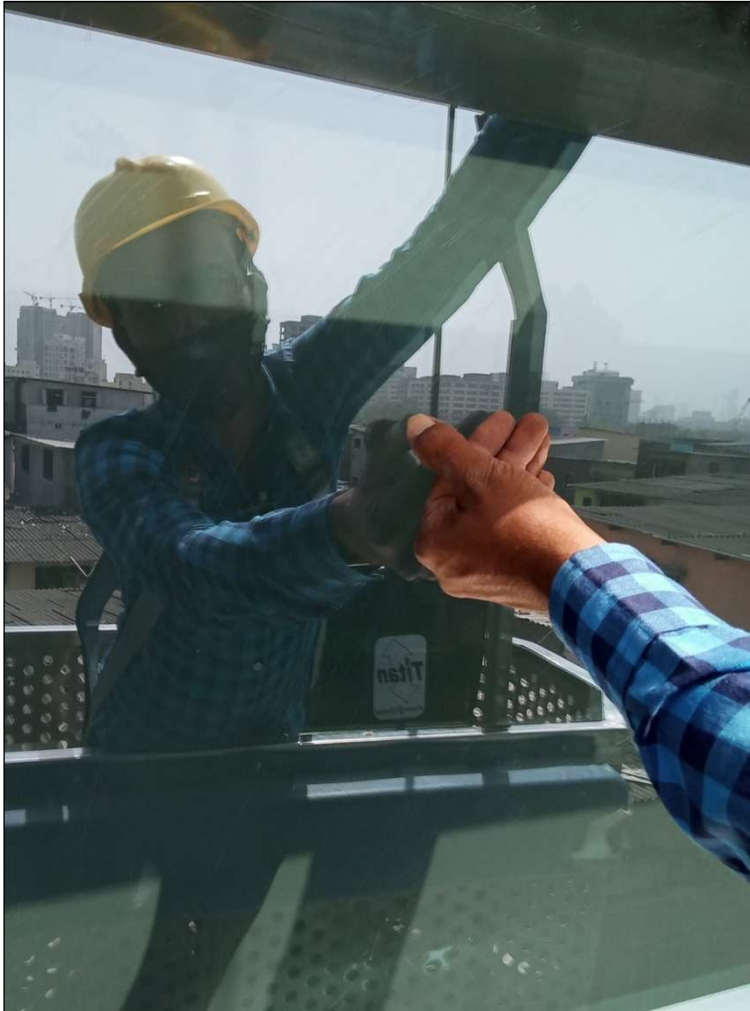
Scratches (Hairline Cracks) on Glass
Floor :3rd Floor ; Panel below Openable Window

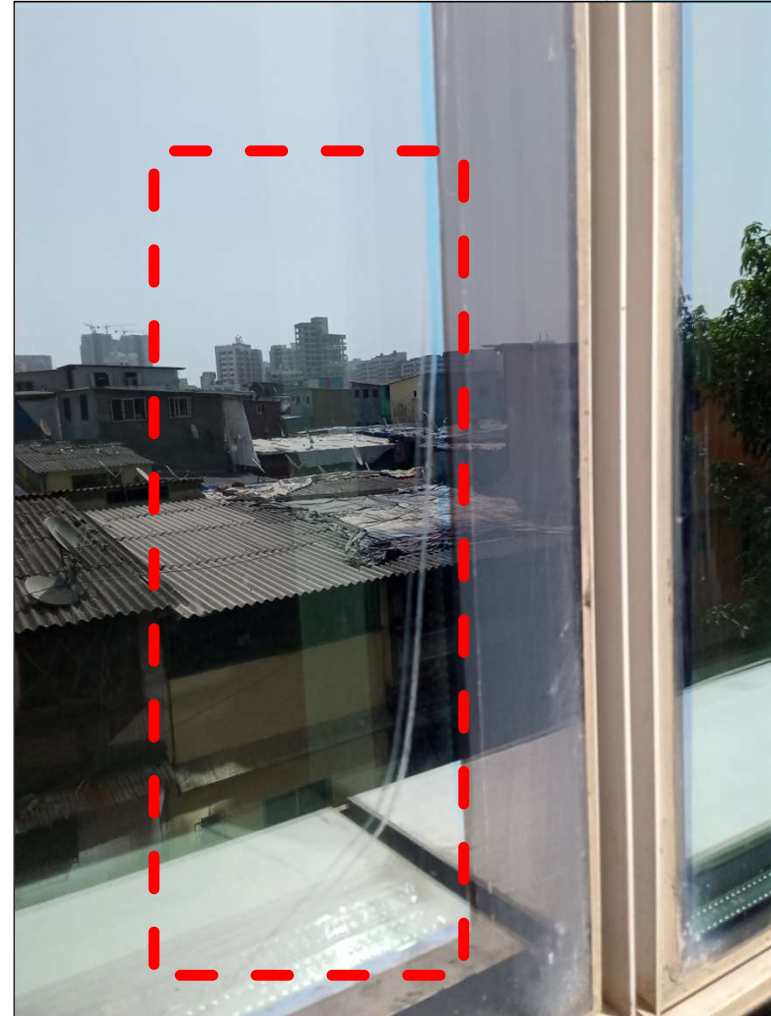
Big Scratch on 2nd Floor ; Panel below Openable Window

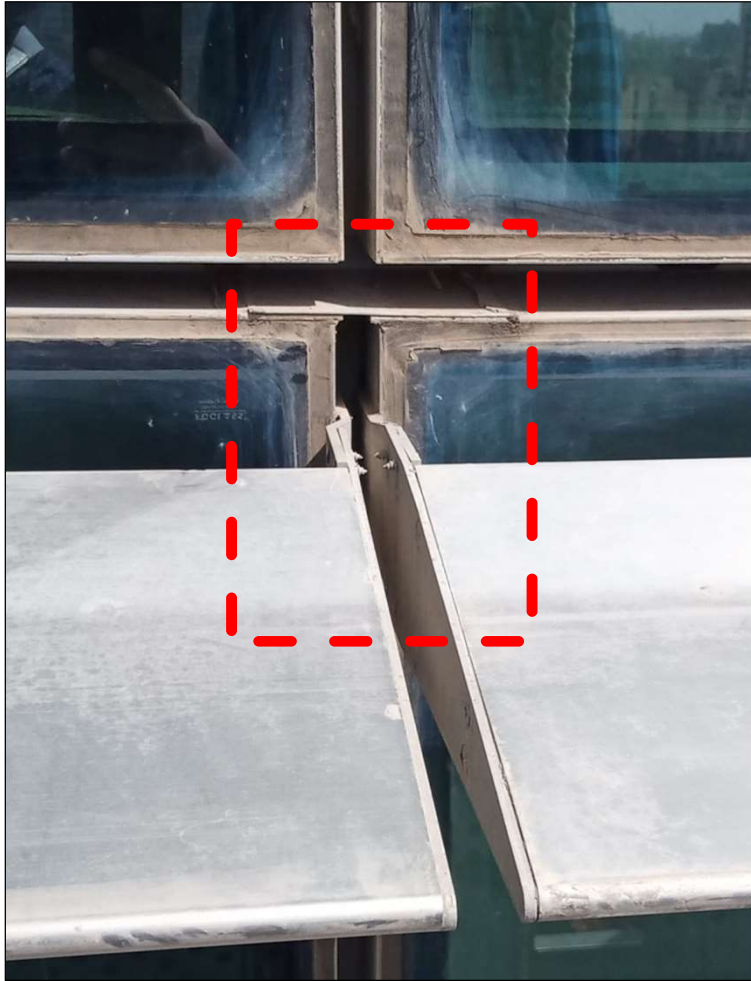
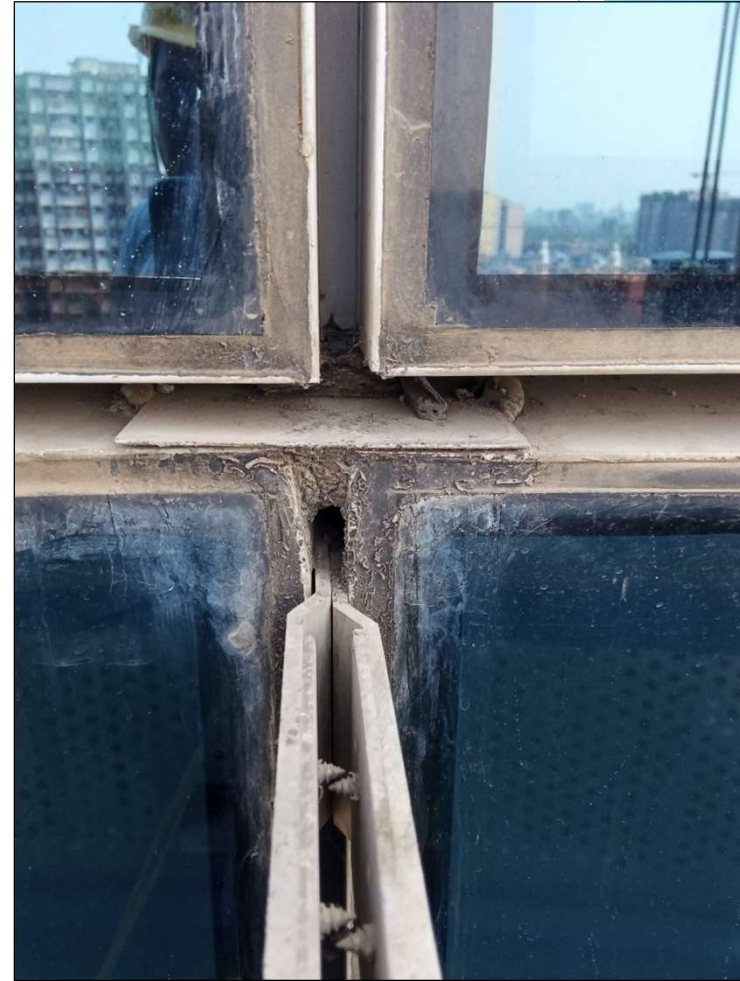
Grooves to be filled with Silicone at Top of Bracket wherever possible and wherever left
(Image at Right Side is noted at Elevation A, near Grid 6 where silicone is place at bracket)

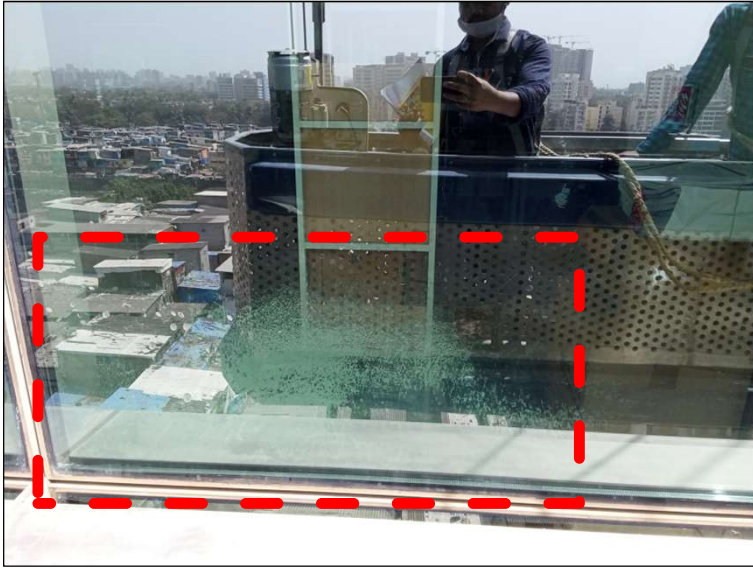
Dirty Spot on Glass from Inside

Floor :3rd Floor ; Panel to be checked from Inside

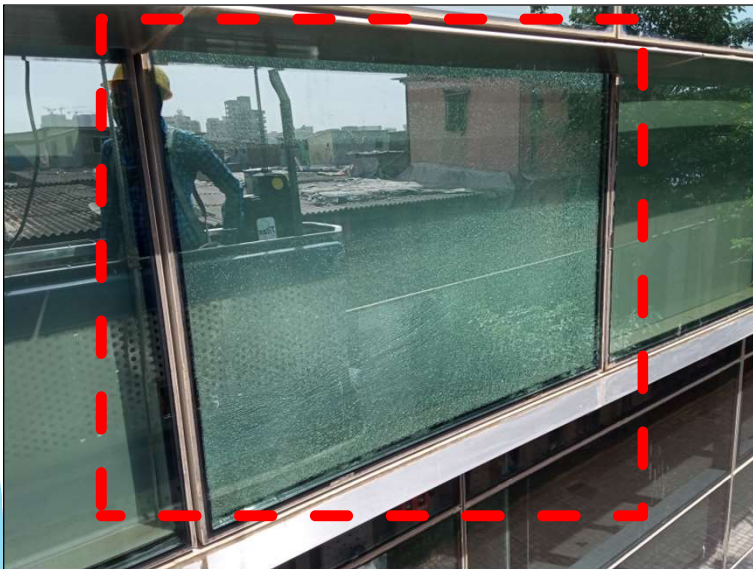
Broken Toughened Glass at second floor

- Broken Glass at second floor is not replaced after shifting the cradle at this location. (only at 5th floor, broken glass is replaced.
- This happens because of Impurity (Nickel Sulphide Inclusion) in Glasses.
- This can be avoided by Heat Soaking Process on Glasses during Fabrication.
- It costs higher than Non Heat Soaked glass and for Smaller Quantity Processors do not take order for Heat Soaking .

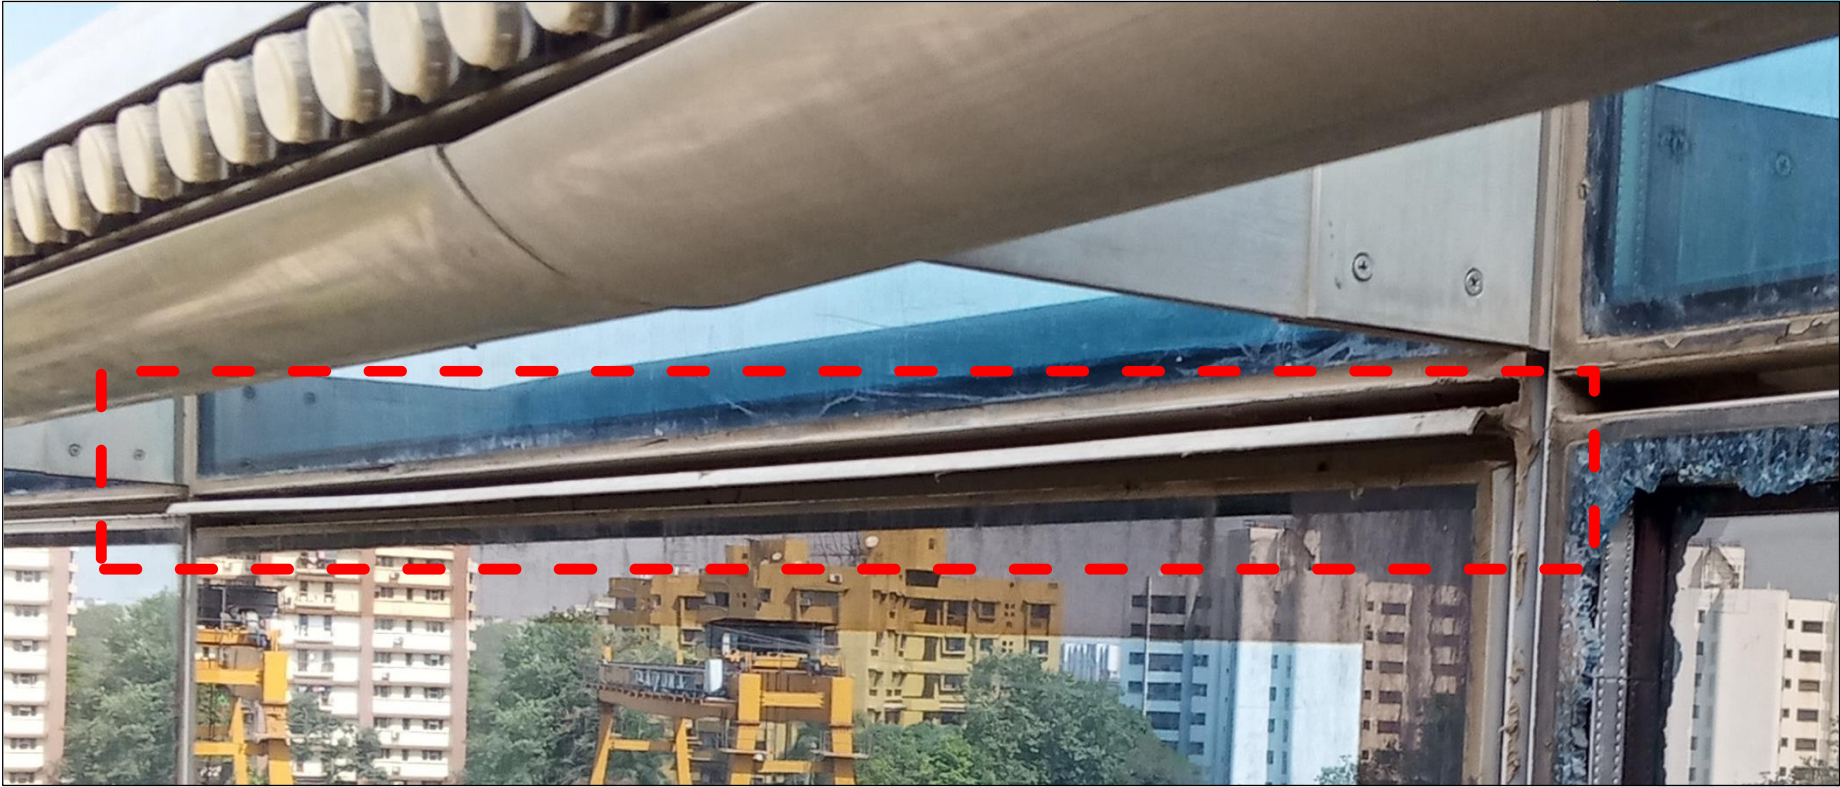
Location: 3rd Floor ; Panel besides Openable Panel

Observation: Water accumulation at the Openable Window to be checked from Inside

- Length of Flashing Protruding outside seems less.
- If required additional flashing maybe required

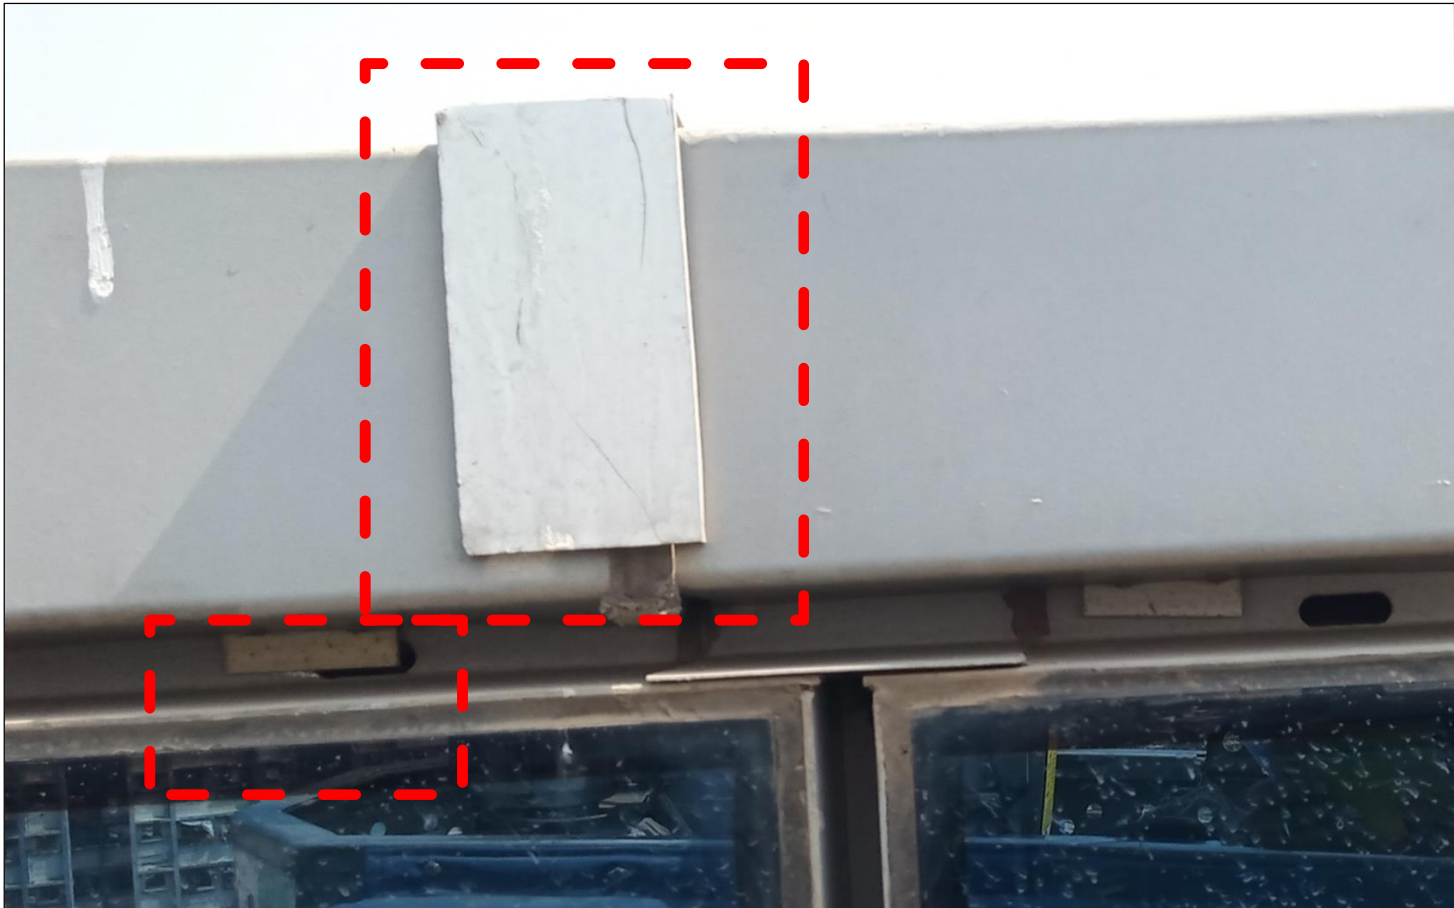
Location : Terrace Level

Observation : Weep Hole is obstructed by 1mm Thk. Aluminium Sheet. Silicone missing at the sides of ACP strip.

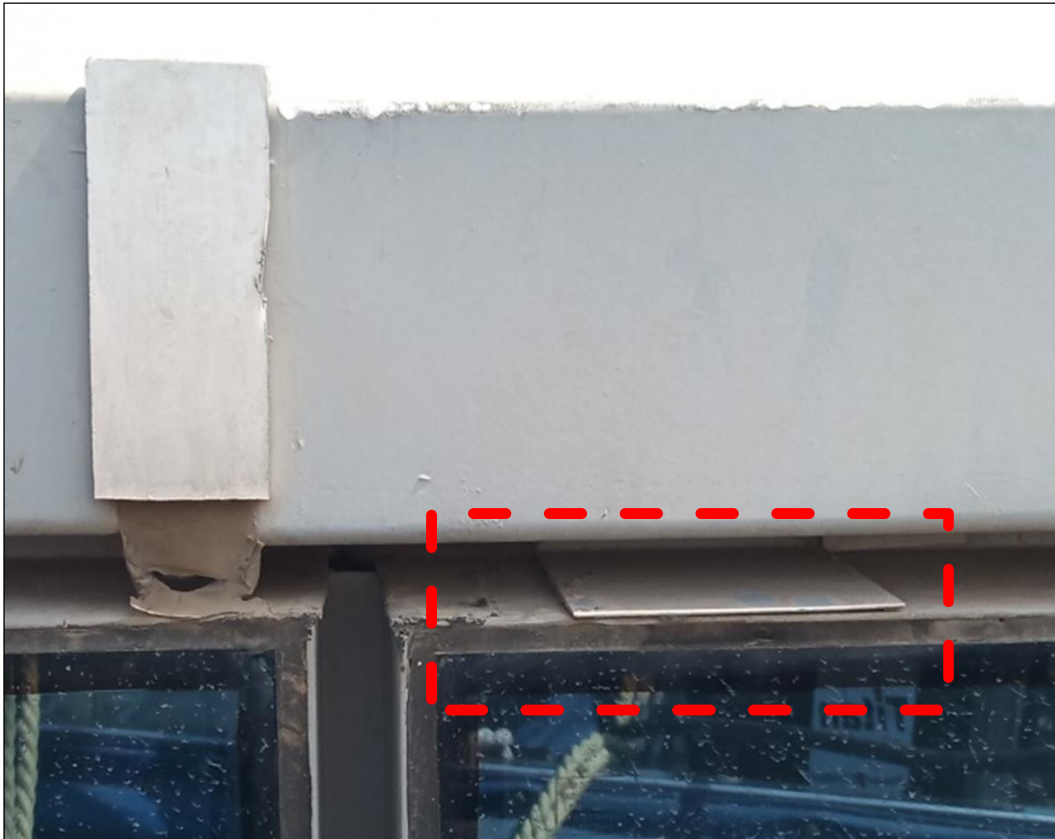
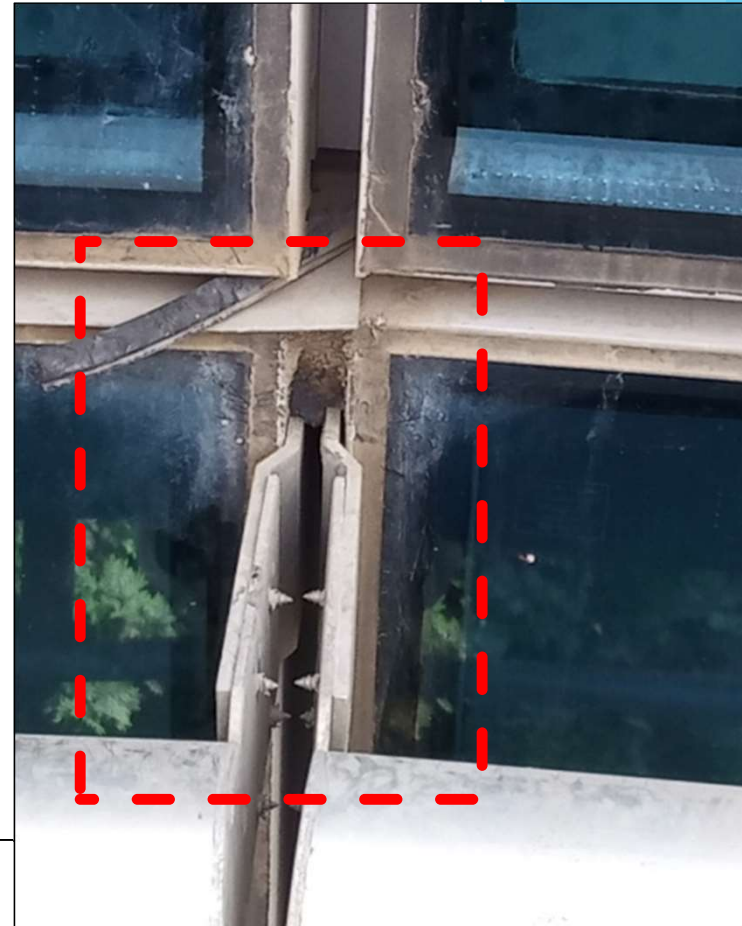
Location : Terrace Level

Observation: Dislodge 1mm Thk. Aluminium sheet. Should be placed as like in another image.

Solution: Silicone with Baker Rod to be placed at every location where such Alum sheet is placed for confirmation of proper closure at mullion

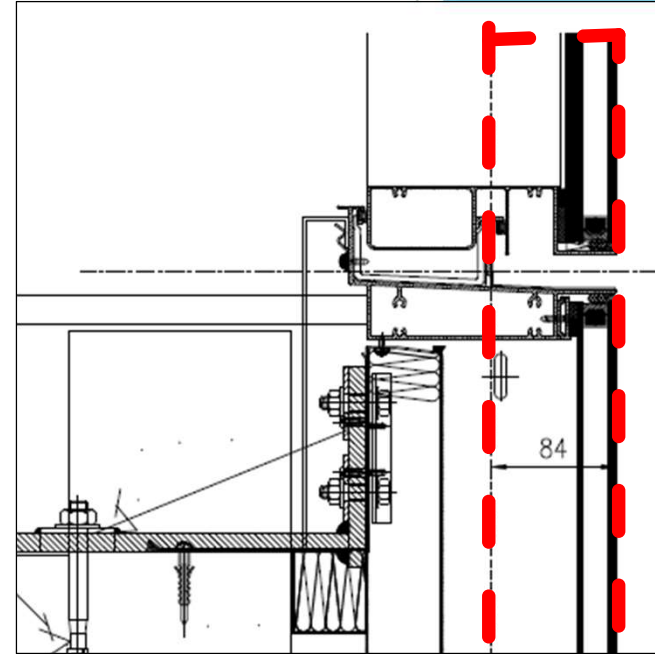
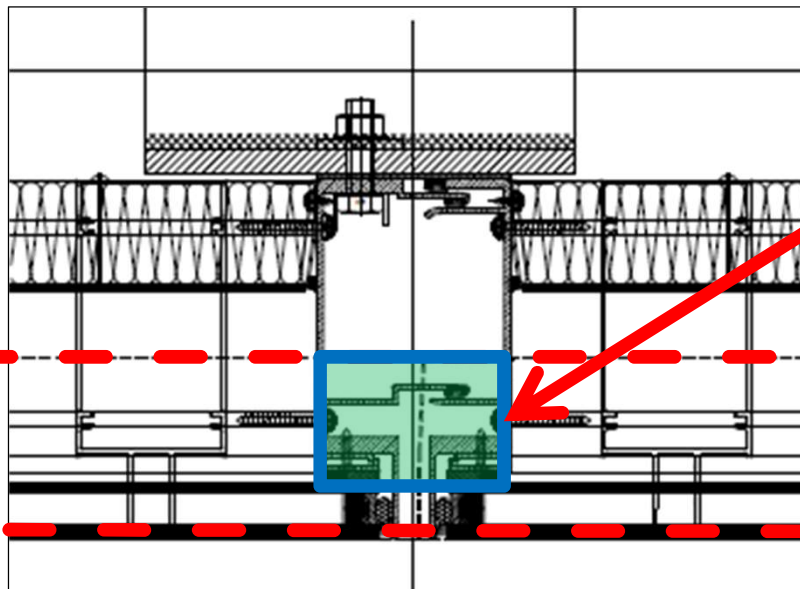
**AREA AFFECTED
DUE TO
DISLODGE-
MENT
OF GI SHEET**

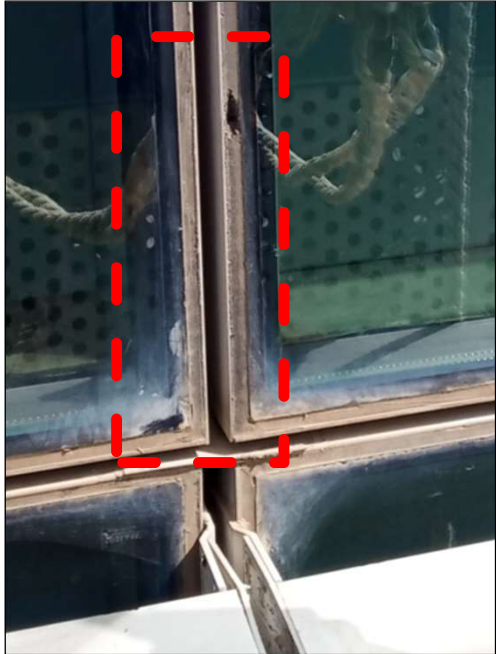
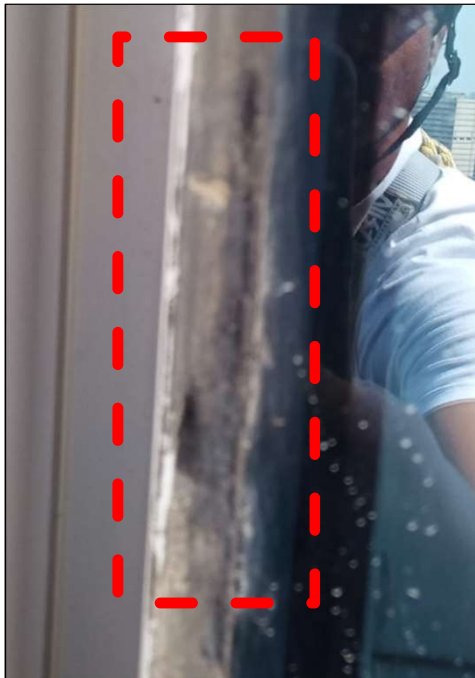
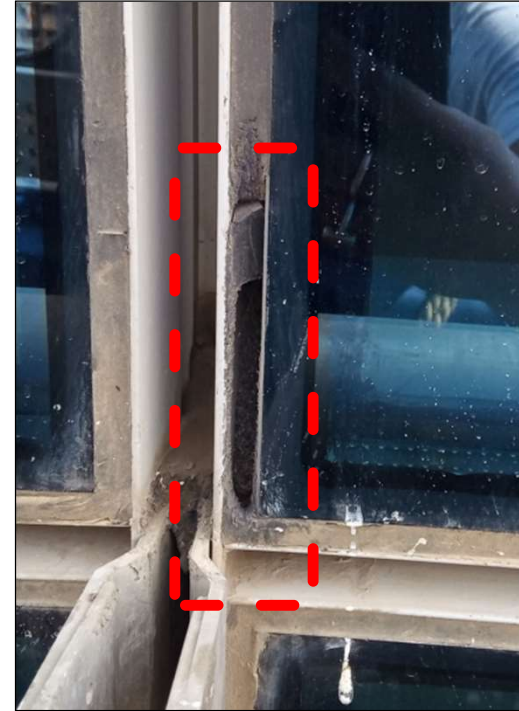
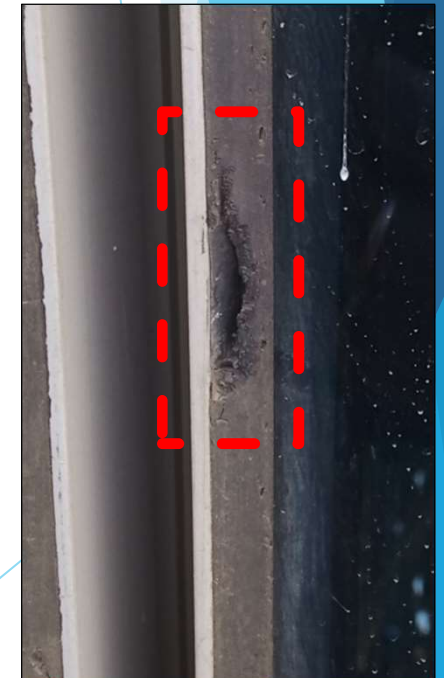
Location: Various Locations

Silicone Removed (by Birds)

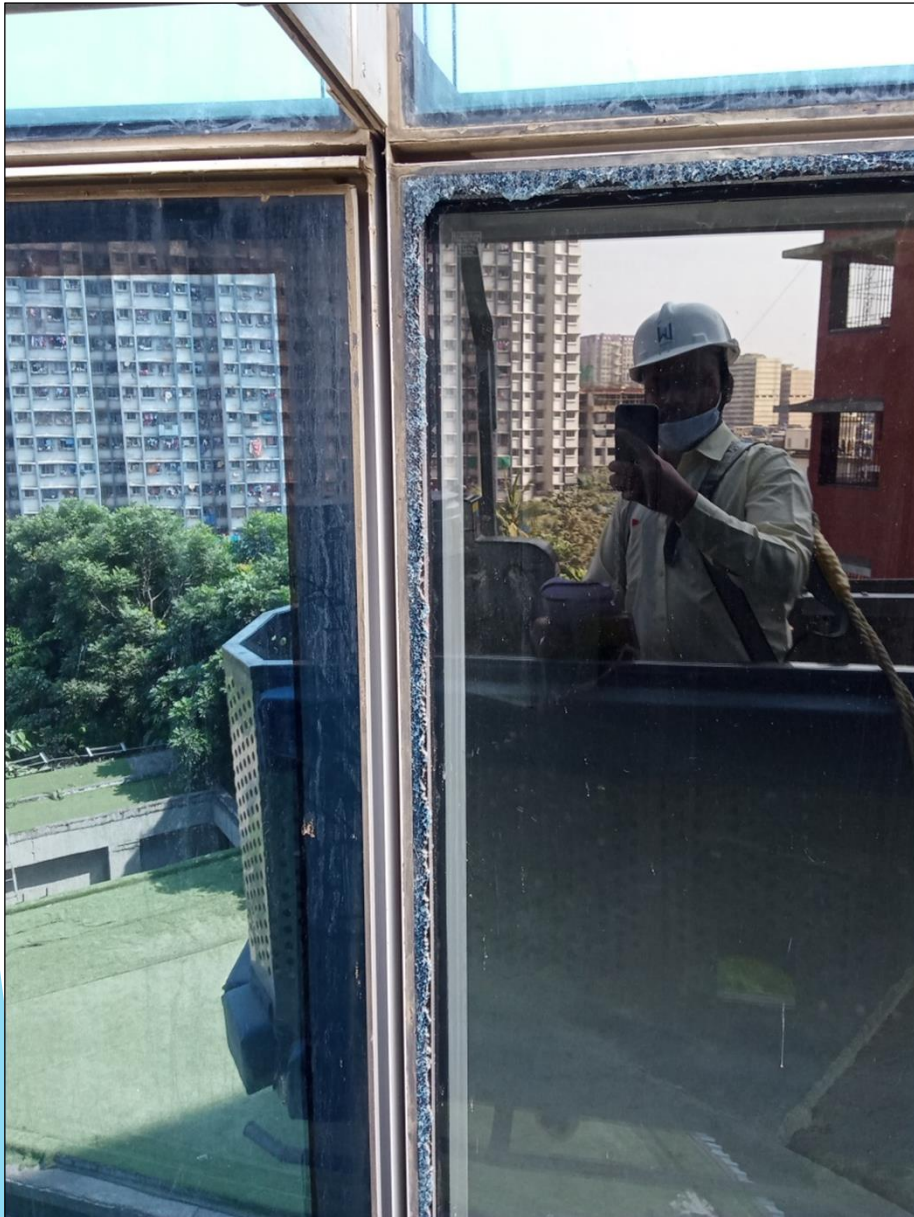
Broken Glass

Floor :3rd Floor ; Panel for which shifting is done.

Broken Glass is replaced with New DGU.

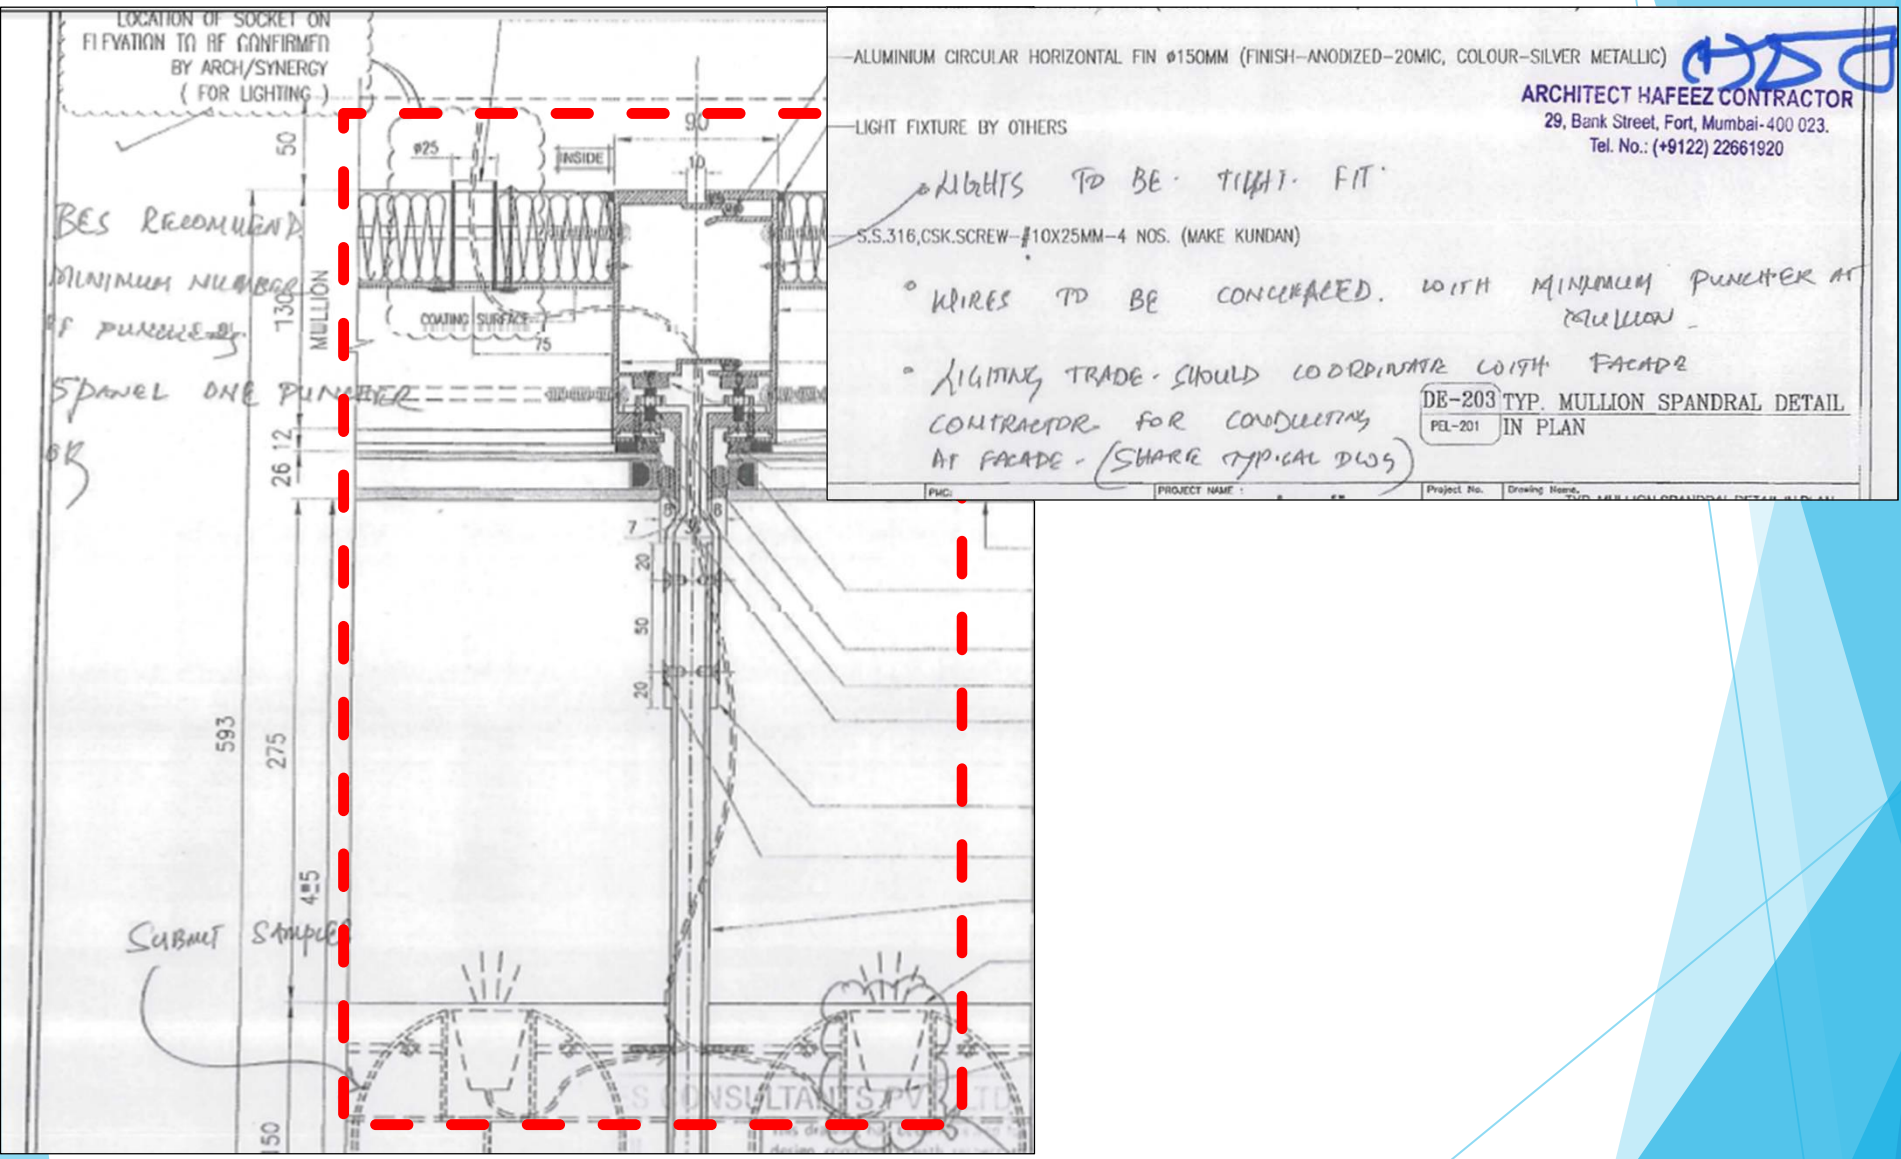
Mullions are punctured for Cable of Lighting Fixture
