PROJECT REPORT

Façade Maintenance Work for Pragati Building at L&T Electrical & Automation Division, Mahape

18 November 2019

10 January 2020

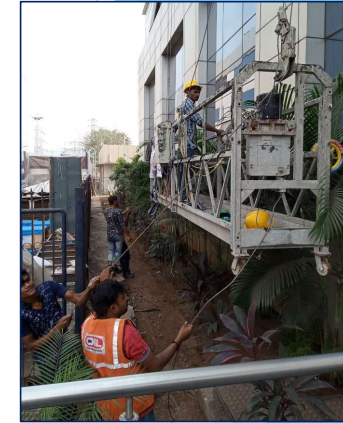
Pulling Cradle to Jump to
required Level to Save Trees
