PROJECT REPORT

Façade Maintenance Work for Pragati Building at L&T Electrical & Automation Division, Mahape

18 November 2019

10 January 2020

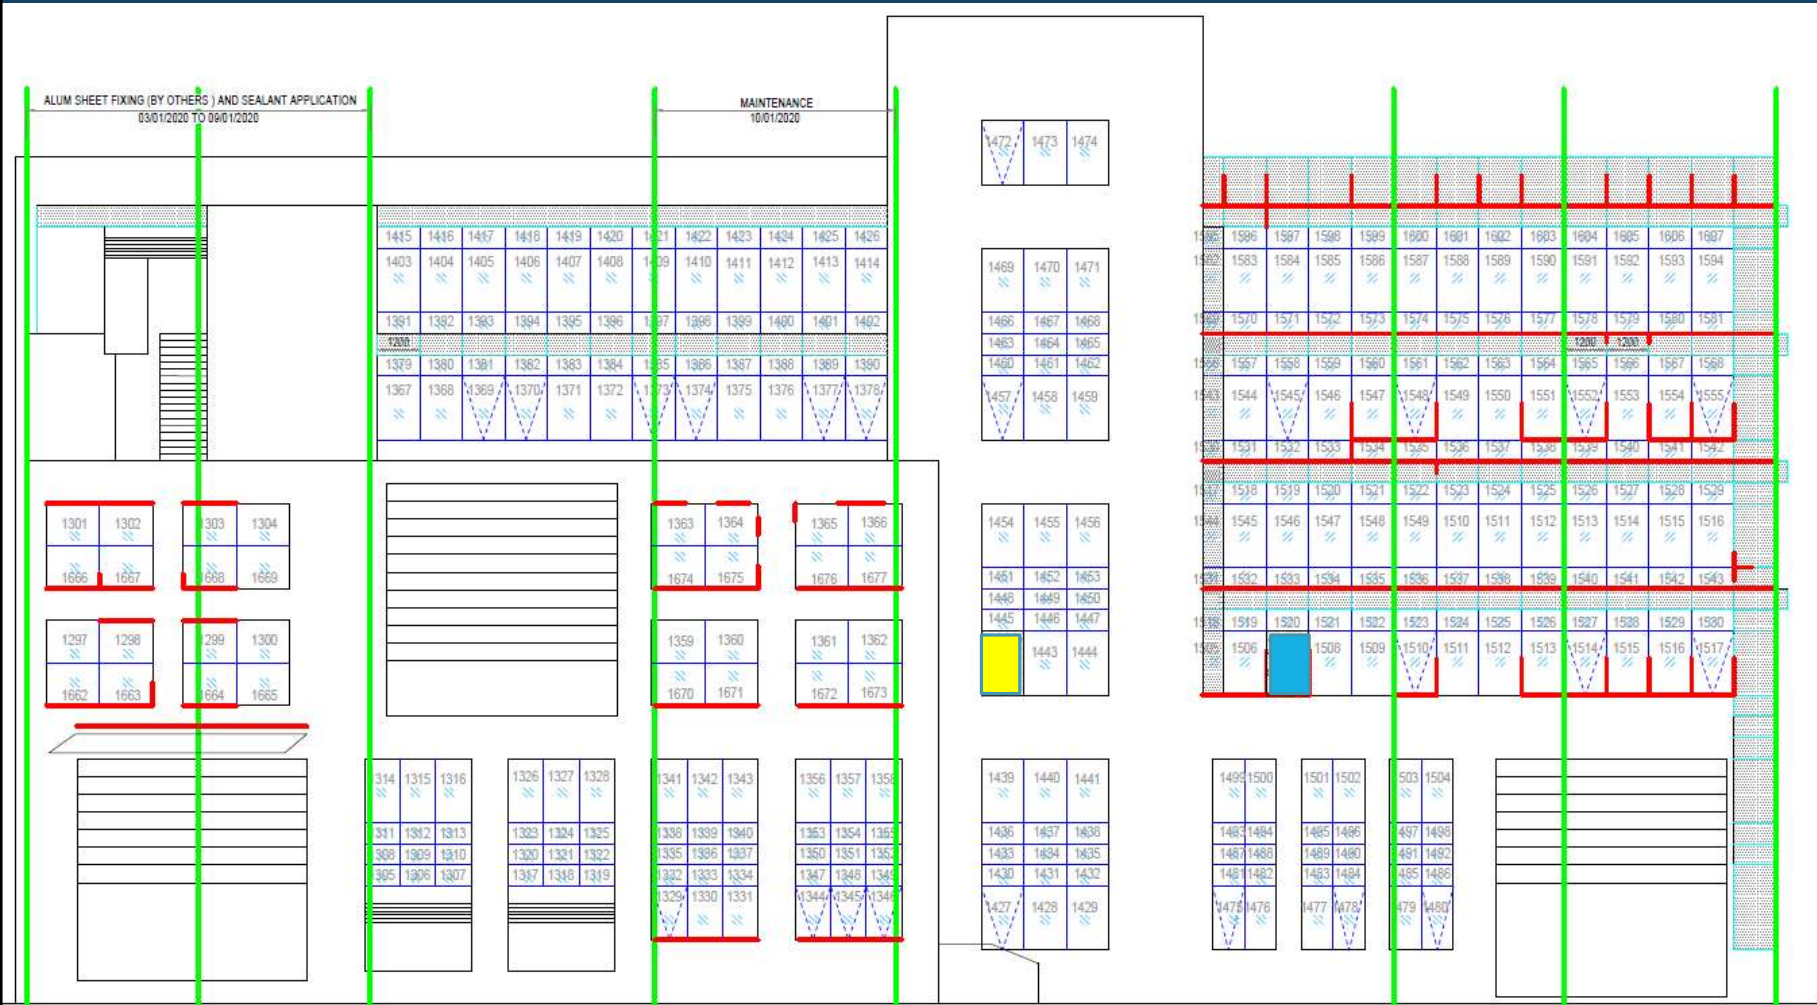
Detailed Data for Completed Work-Left Elevation

Hinge and Arms Replacement : 1 Nos.

Fresh Sealant application: 609 RFT

Glass Replacement : 1 No.

Gondola Shifting: 6 No.

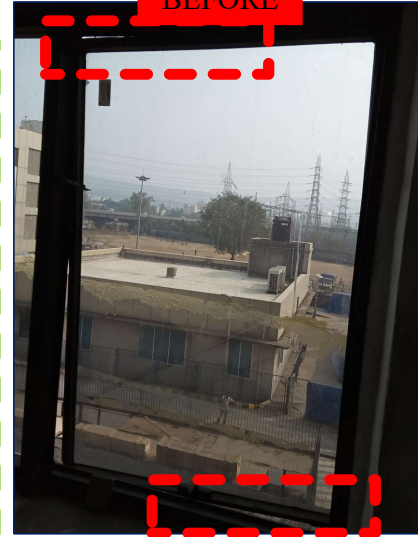
BEFORE

Window 1442: Misaligned Top Hung Window about to fall.

Hinges replaced and Restrictor Arms installed

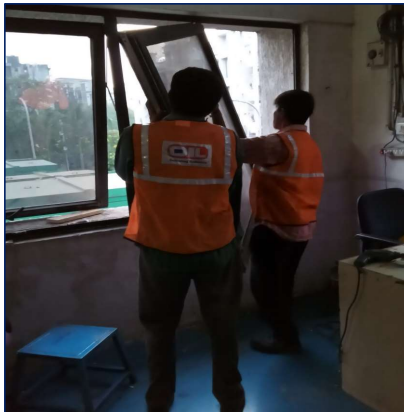
Window 1070 converted from Fixed Glass to Openable

Maintenance of Window 1070, 1071, 1072.

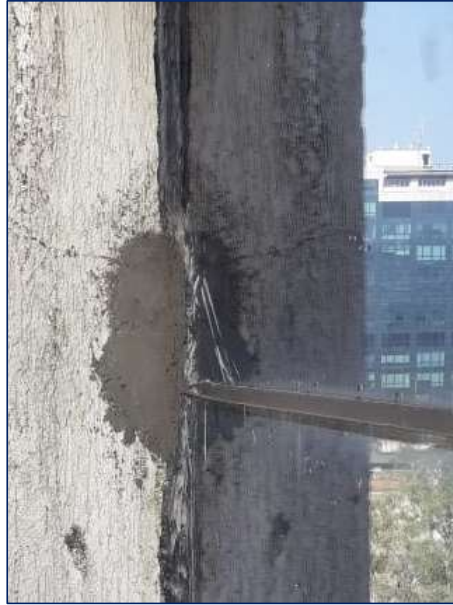
BEFORE

Identifying Leakages in RCC and Filling Cracks (By others)

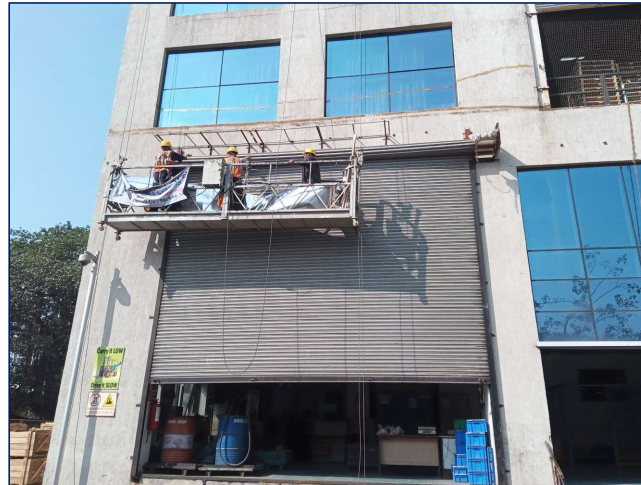
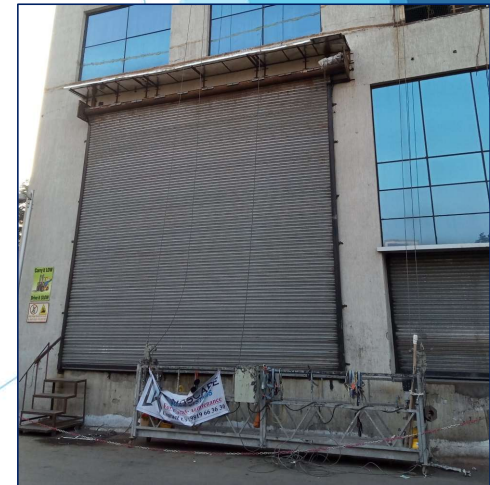
AFTER

Fabrication and Installation of Aluminium Sheet above Shutter (By others)

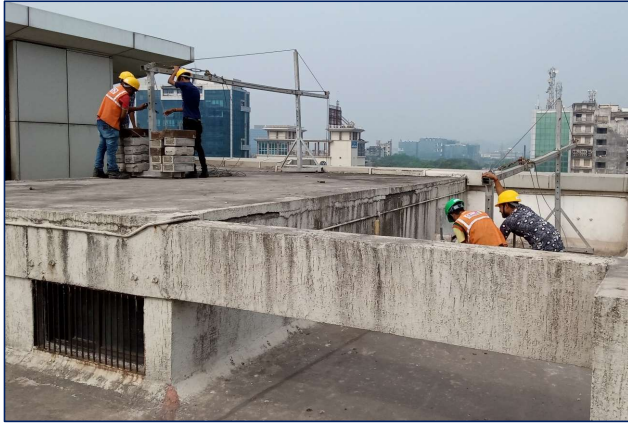
Counterweight at Different Height
(for Front Elevation at Right Side)

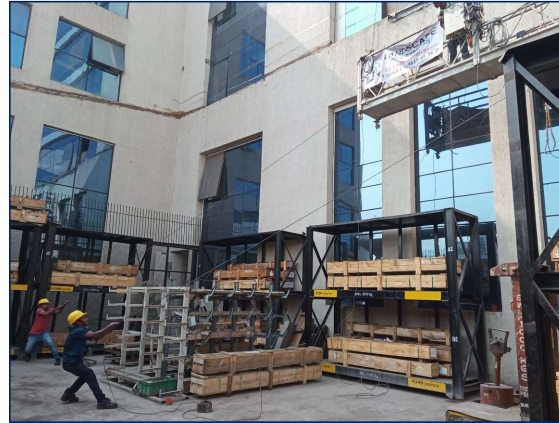
Pulling Cradle to Jump to required
Level to avoid Clash with Structure

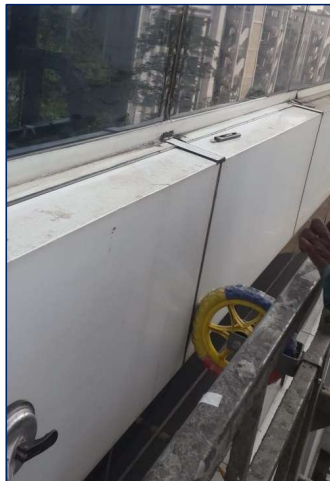
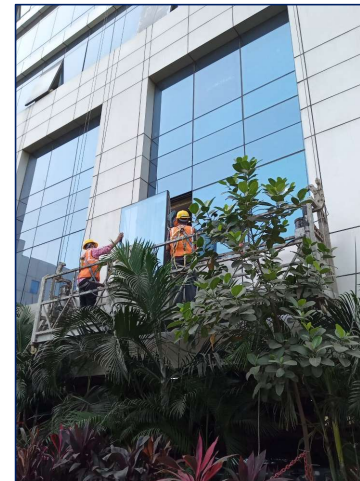
Inadequate Space to Work
